DELAWARE RIVER BASIN  
NORTH BRANCH TIMBER CREEK,  
CAMDEN COUNTY  
NEW JERSEY

# NEW CAMP SITE DAM NJ 00412

## PHASE 1 INSPECTION REPORT NATIONAL DAM SAFETY PROGRAM

11 Aug 1979

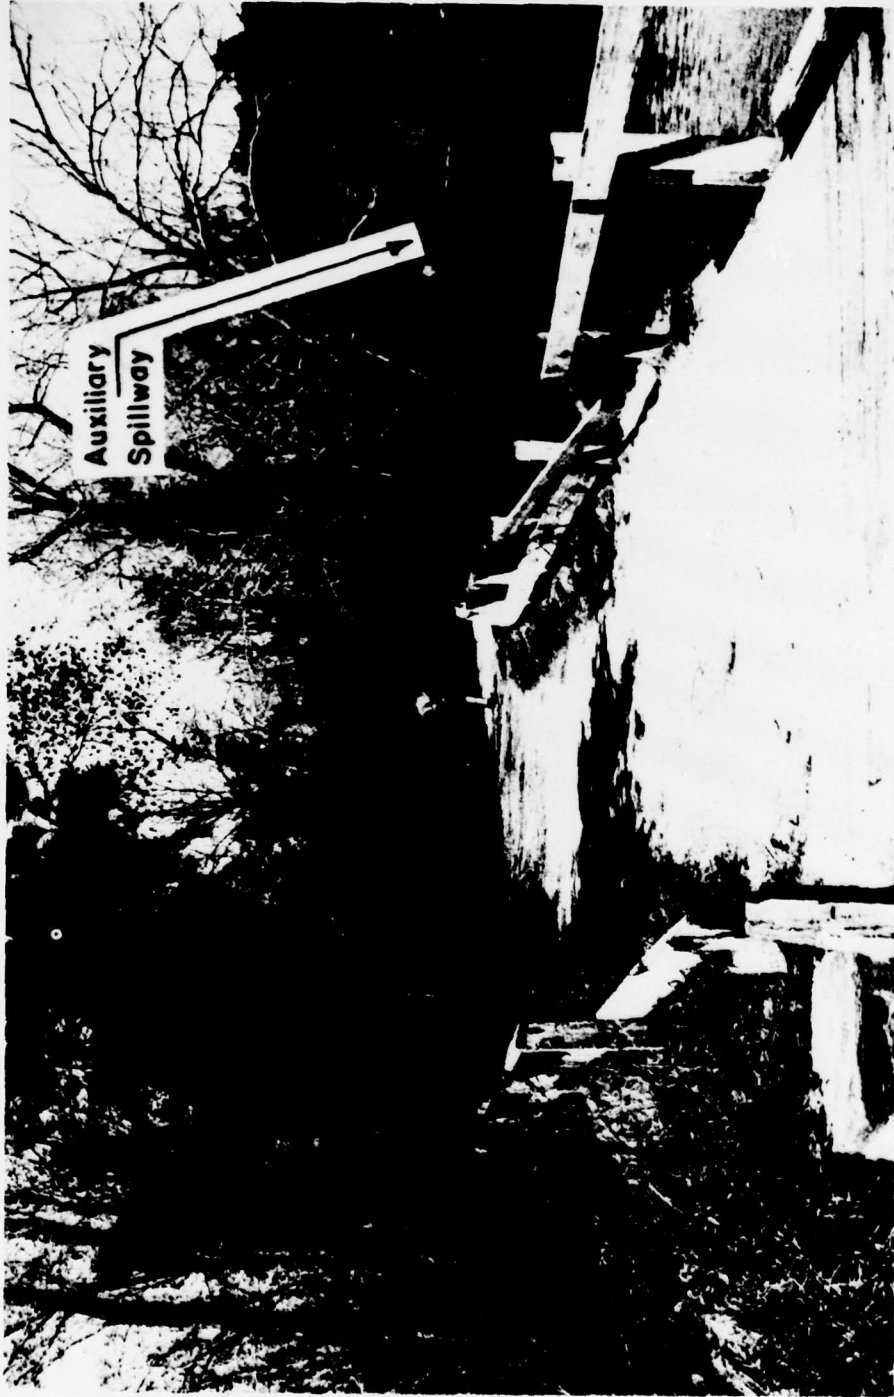
OVERVIEW OF NEW CAMP SITE DAM

The New Camp Site Dam is judged to be in a fair overall condition but considerable seepage was observed below the spillway and along the backslopes. The embankment is over 70 years old and has withstood the test of time but additional engineering studies are recommended to assess the continued stability in view of the observed seepage. Further, the feasibility of removing the auxiliary spillway should be studied. No other detrimental findings were uncovered to render a questionable judgement as to the structural stability except the downstream splash apron at the auxiliary spillway is in an advanced stage of collapse. Recommended remedial actions to be undertaken in the near future include 1) regrade and protect the downstream embankment slopes at the spillway 2) remove the trees on the downstream

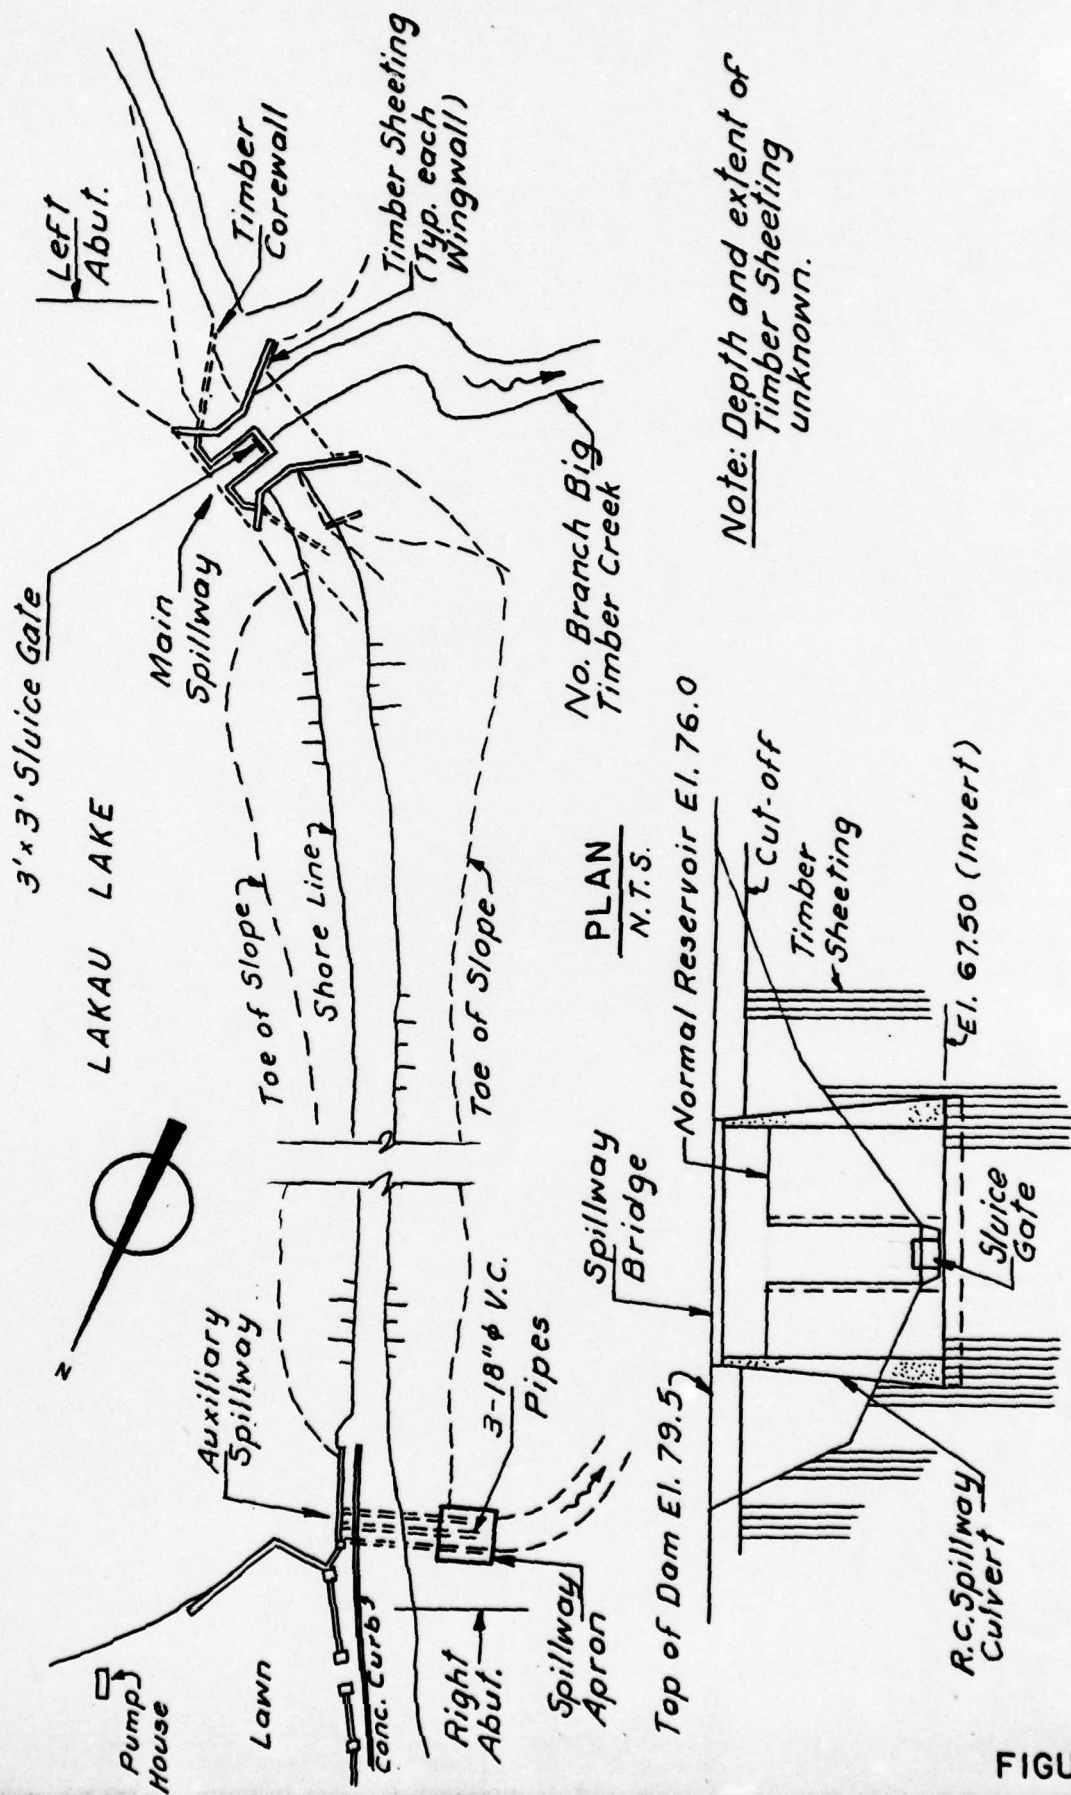
SECTION THRU SPILLWAY

and details are depicted in sufficient detail so that a meaningful structural assessment can be made. It was noted that weepholes were not provided to relieve uplift but after over thirty years, the timber sheeting can no longer be watertight.

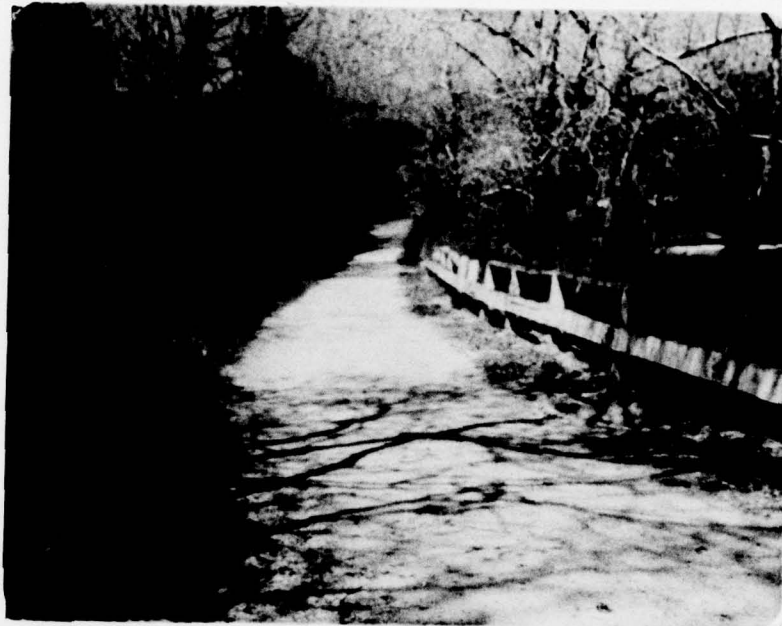
View of Crest

The roadway embankment, which forms the main dam structure, was assessed to be in a solid and stable condition although the slopes are heavily wooded and irregular, varying from 1:1 to 2H:1V. The crest of the dam is an irregular dirt access road that appears infrequently used. There are numerous fair sized trees (4" to 18") growing along each side of the crest and considerable siltation was noted in the reservoir immediately upstream from the dam. Many of the mature trees along the lake are tilted towards the reservoir which indicates an undercutting of the root systems. The roadway profile is fairly level across the dam but rises on either end just past the abutments. There was no riprap protection observed at this site and numerous backslope areas are deeply sloughed out. Two extensively large areas in the natural terrain below the toe of downstream slope were wet and this appears to be the result of seepage. Additionally, a wet area was observed below the left downstream wingwall at the main spillway. A portion of the discharge channel parallels the downstream toe of slope and could be obliterating any evidence of seepage in that zone.
